Confidential Inspection Report

1221 Any Avenue

Oakland, CA 94610

September 11, 2014

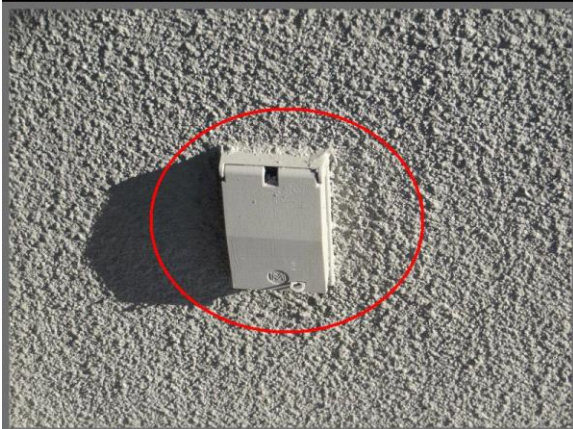
No in-use watertight cover

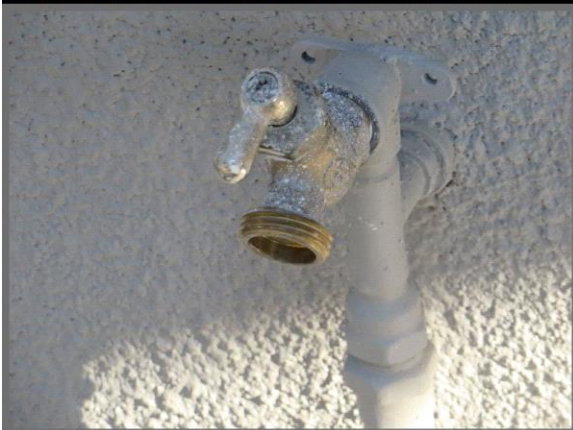
ACTION ITEM - We discovered several cross connections. We recommend all cross connections be eliminated. Location: The exterior hose bibbs (faucets). Location: The kitchen faucet with a built-in pull-out sprayer.

NOTABLE CONDITION - The front faucet handle is broken and should be replaced.

Hose bibb w/o backflow & broken handle

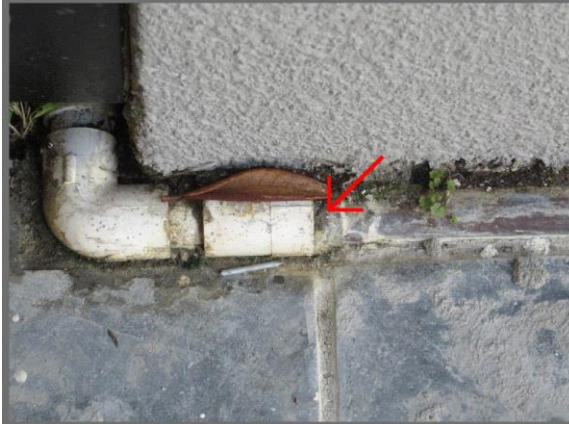
NOTABLE CONDITION - A section of copper water piping located at the front of the home is connected to PVC plastic piping (metal threads installed into a plastic fitting). No leakage was discovered, but technically this installation is nonconforming. We recommend repair.

Copper connected to PVC

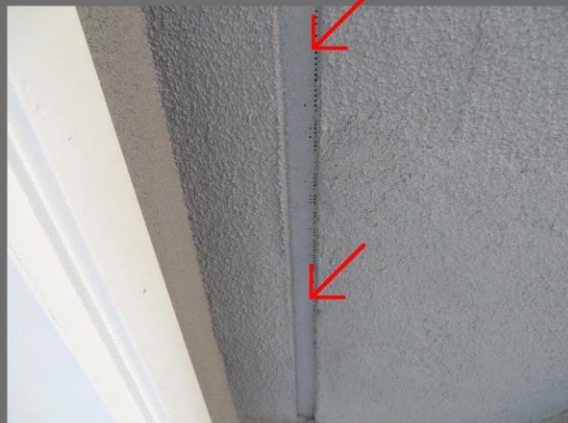
Vent screen painted over

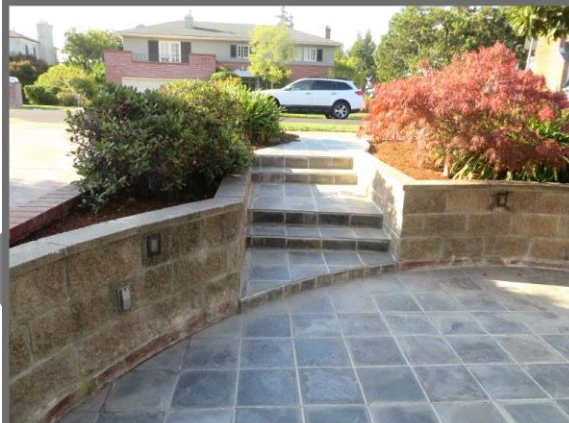
Nonconforming steps

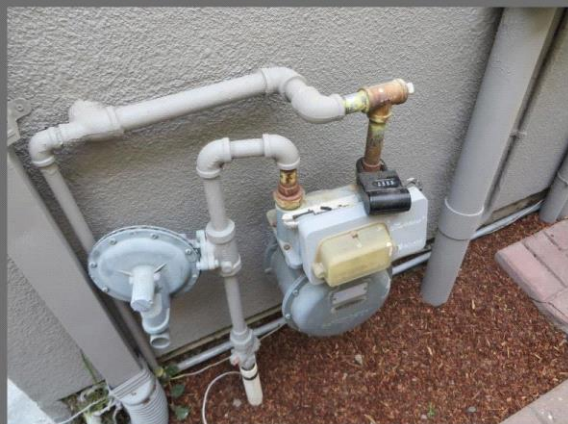
NOTABLE CONDITION - The meter gas piping is corroded. We recommend this piping be fully prepped and painted to maximize its remaining service life.

NOTABLE CONDITION - This building does not have either an earthquake-actuated gas shut-off valve or an excess-flow gas shut-off valve. We recommend the installation of one of these valves.

Corroded piping & no earthquake valve

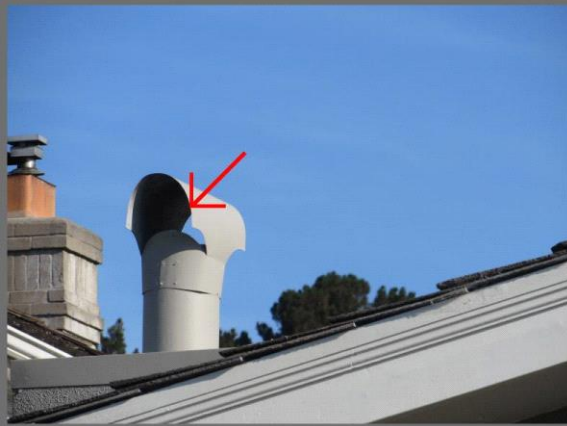
Nonconforming rain cap/spark arrestor

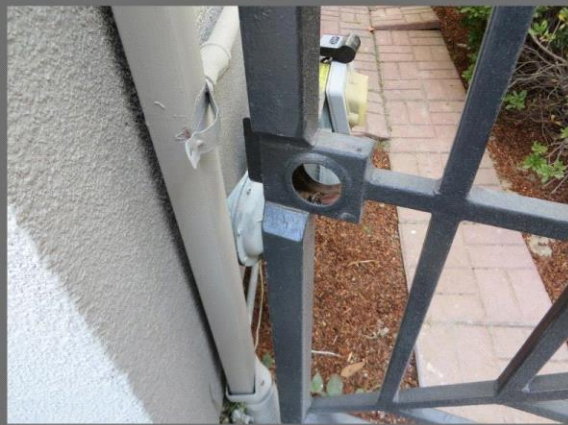
Side yard gate w/o lock

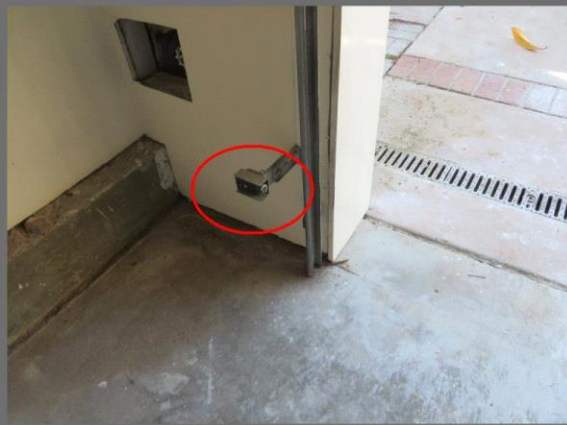
Infrared beam too far above floor

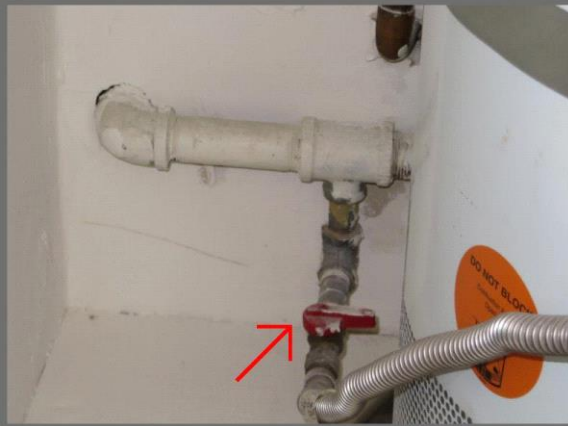
NOTABLE CONDITION - A sediment trap (sometimes referred to incorrectly as (Drip Traps or Drip Legs), is a small "Tee" pipe assembly installed in the gas line just before the appliance. The idea is that any debris/sediment in the gas will fall into the trap before it reaches the appliance gas control. The gas control valve is a sensitive device. Any debris that contaminates the control can cause the system to operate unsafely. The requirement for sediment traps has been around for years. Older Mechanical and Plumbing codes had requirements for sediment traps when local natural gas had debris in it. In the last California Code cycle, sediment traps became mandatory under all circumstances. Most gas furnace and gas water heater manufacturers have required them for years as well. The manufacture warranties will more than likely be void or invalid if these traps are not installed. A sediment trap is a few dollars of pipe parts and 15 minutes of labor. This appliance does not have a sediment trap and we recommend one be installed.

No drip leg

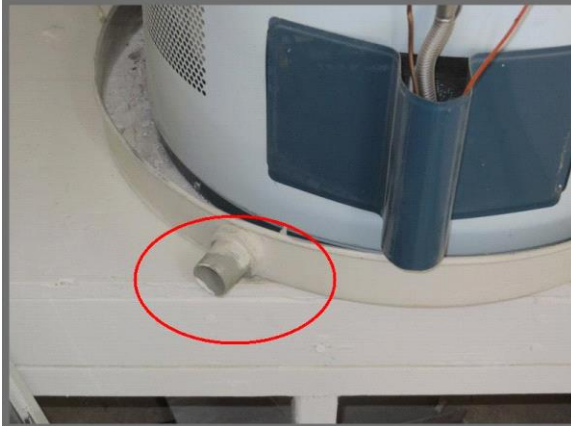
NOTABLE CONDITION - The water heater is equipped with a drip pan, which is designed to minimize water damage from a leak, however, the pan does not have a visible drain pipe to drain the pan. We recommend a drain pipe be installed and directed to the exterior of the building or to another approved location.

Drain pan w/o drain pipe

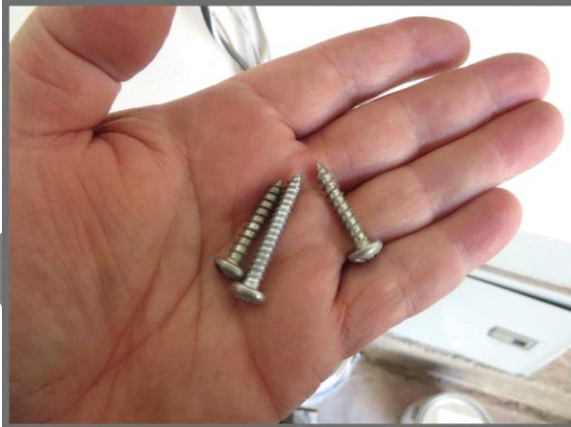
Wrong screws for electrical panel

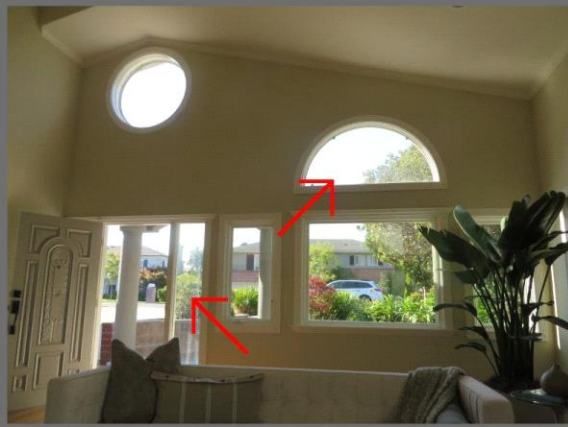
Failed seals

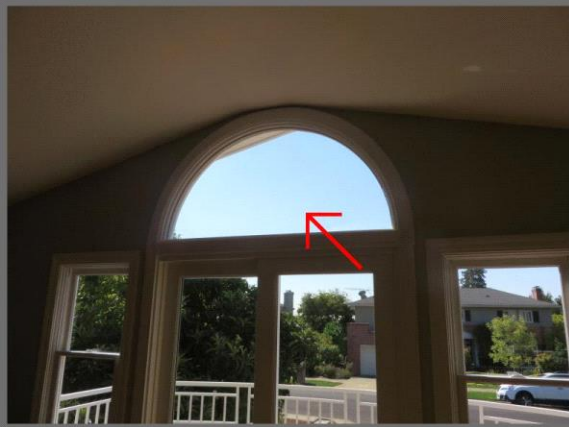
Failed seal

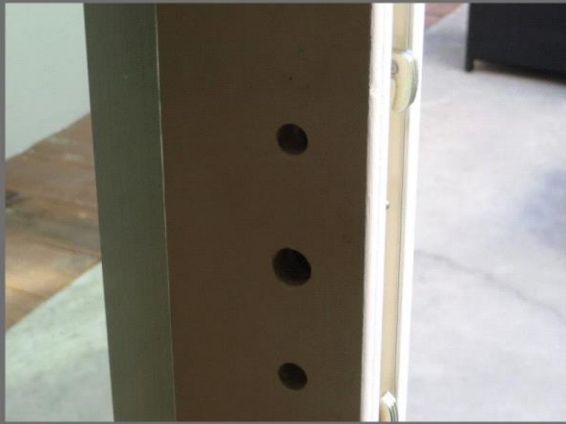
Missing hardware dining room door

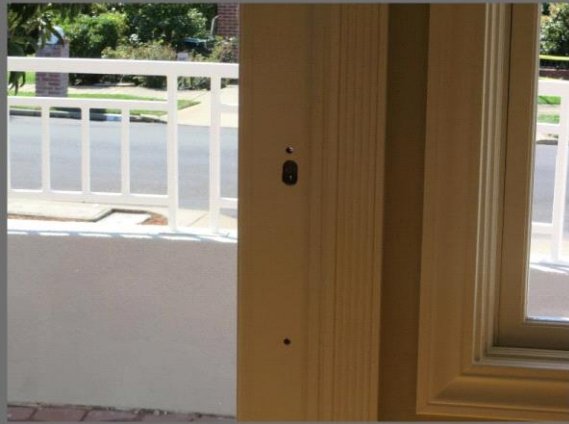
Missing hardware master bedroom door

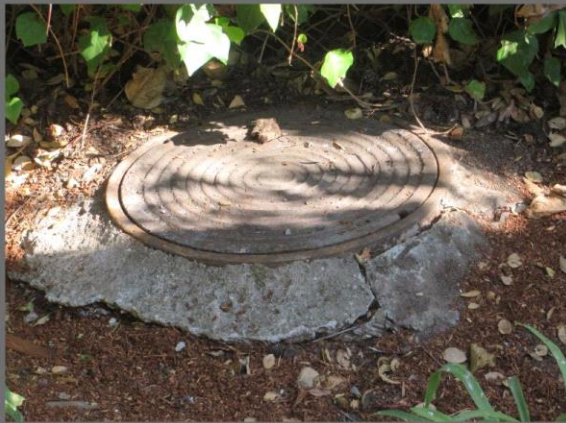
INVESTIGATE FURTHER - A manhole (alternatively utility hole, maintenance hole or access chamber) is the top opening to an underground utility vault used to house an access point for making connections or performing maintenance on underground and buried public utility and other services including sewers, telephone, electricity, storm drains and gas. There is a manhole cover located on this property (back yard). We recommend you check the public records regarding what is present in this utility vault and who is responsible for it should any work be necessary at some point in the future.

Utility vault

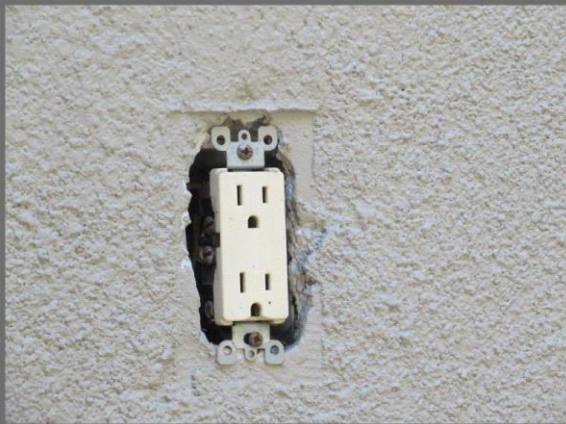
Missing cover at rear receptacle

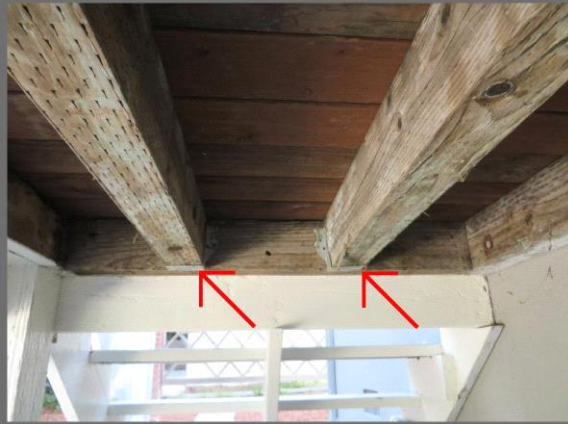
PTF with wrong joist hangers

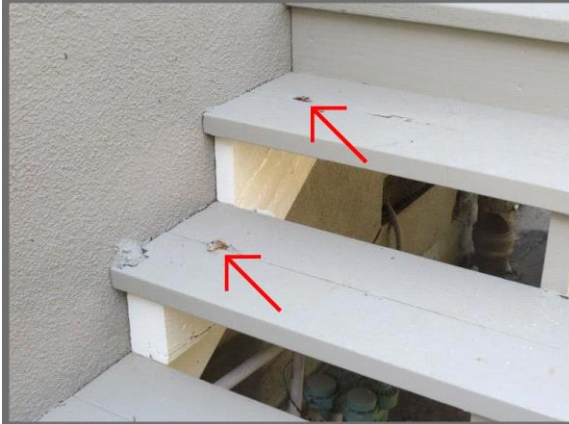
NOTABLE CONDITION - There is evidence commonly associated with wood-destroying pest infestation and/or organism infection at rear deck stairway. All damaged material should be replaced. This type of damage often times extends into inaccessible areas. Therefore, as this repair work begins, additional damage may be discovered. Obviously, any new damage encountered would need to be added to the scope of work and would necessarily increase the cost.

Damaged steps

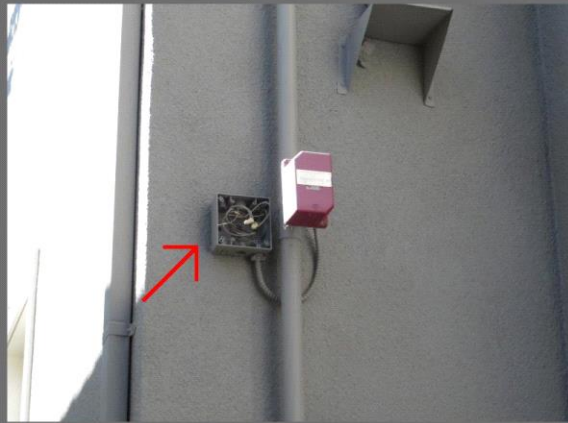
Open junction box

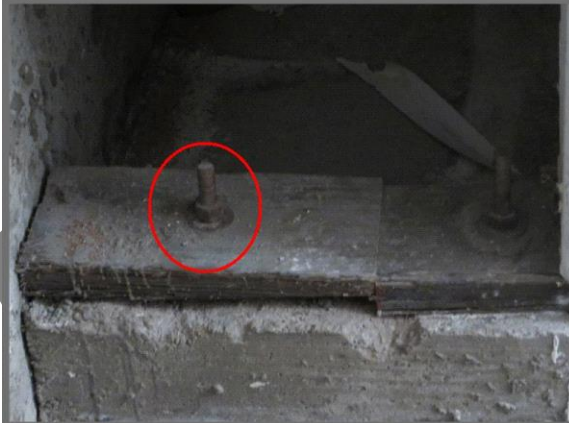
NOTABLE CONDITION - The foundation bolting washers do not meet the latest seismic specifications recommended by many engineers and building departments. Present requirements call for 1/2 inch or 5/8 inch thick, 3 inch by 3 inch square bearing plates. Bearing plates give greater bearing surface than standard cut washers, and help distribute the load at these critical connections. We recommend removing the existing nuts and washers and installing proper bearing plates where practical as part of seismic upgrading.

Ancor bolt w/o bearing plate

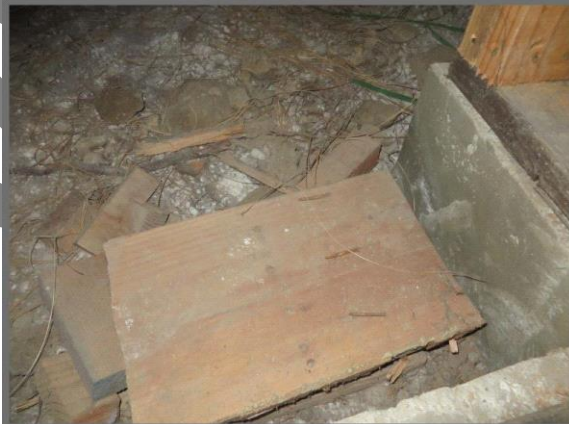
NOTABLE CONDITION - There are scraps of wood and/or cardboard on the soil. The presence of this cellulose debris can result in the infection and/or infestation of wood-destroying pests and/or organisms. We recommend removal.

Scrap wood in subarea

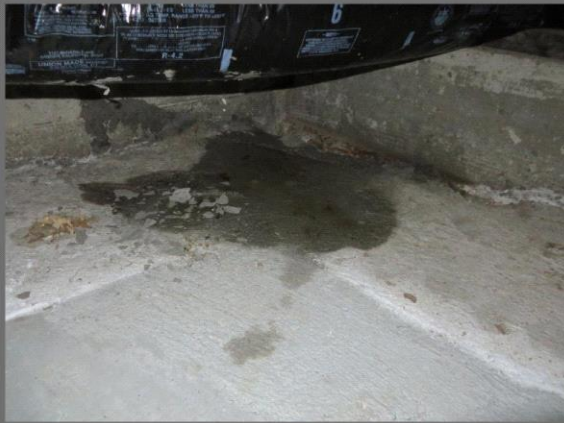
INVESTIGATE FURTHER - We observed a puddle of water in the subarea adjacent to the outside enclosed patio. We further inspection to determine the source of the moisture and the possible need for corrective action.

Standing water in crawl space

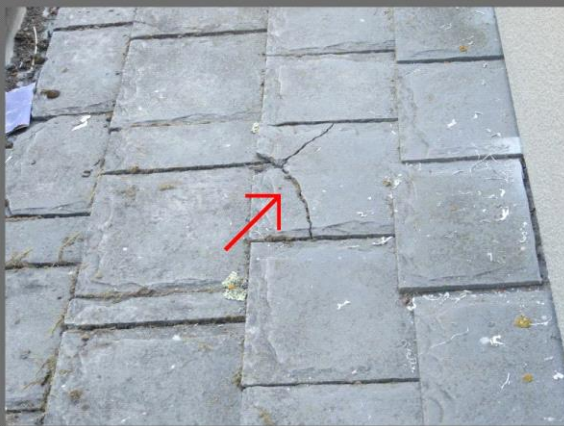
Cracked roof tile

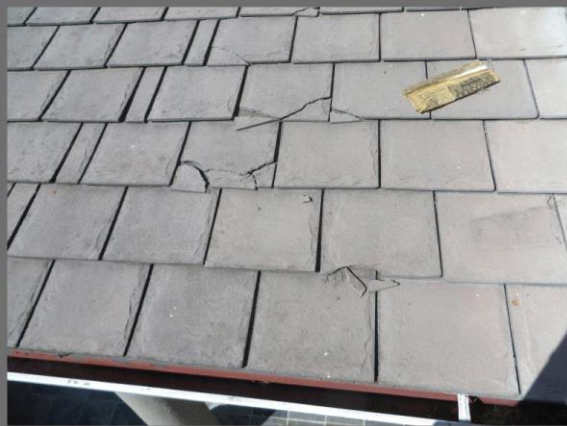
Cracked roof tiles

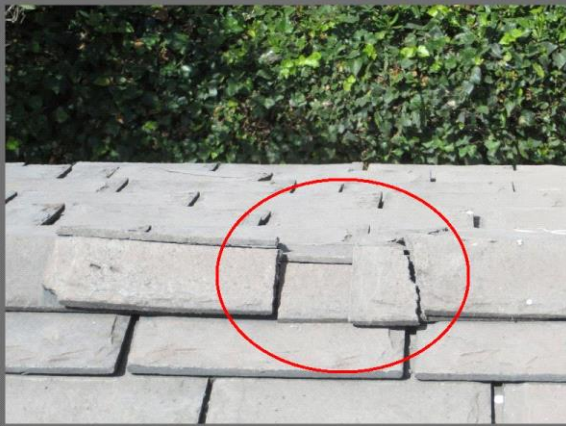
Cracked roof tile

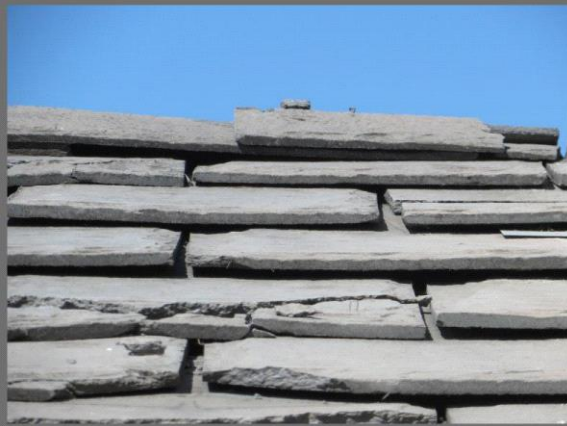
Cracked roof tiles

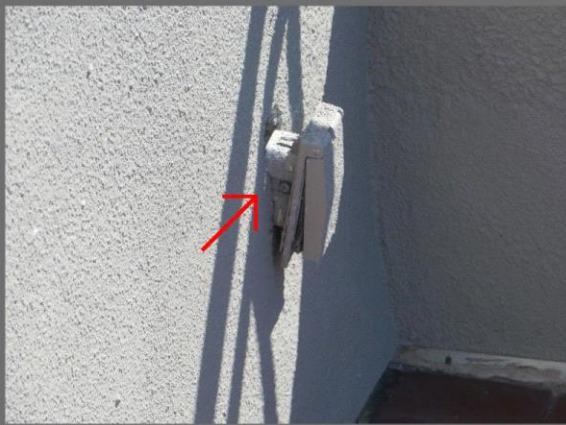
Loose outdoor receptacle

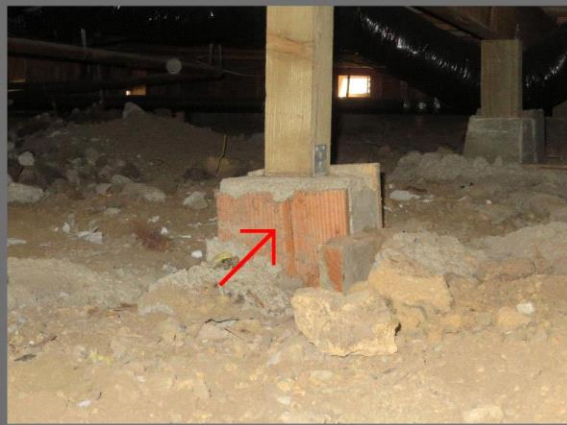
NOTABLE CONDITION - There is form-wood at the base of the piers and foundation walls. The presence of this material is conducive to infection and/or infestation of wood-destroying organisms and/or pests. We recommend all form-wood be treated or removed.

Form wood

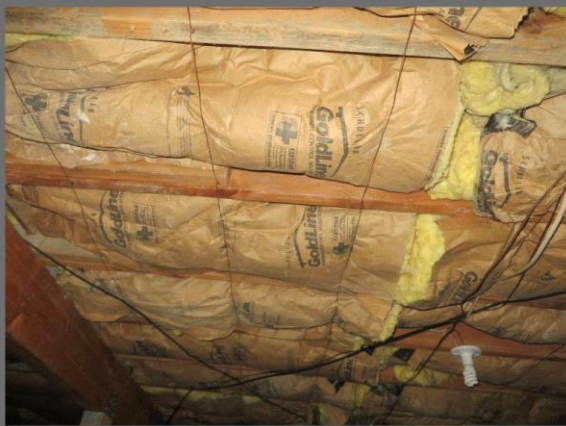
Insulation installed backwards

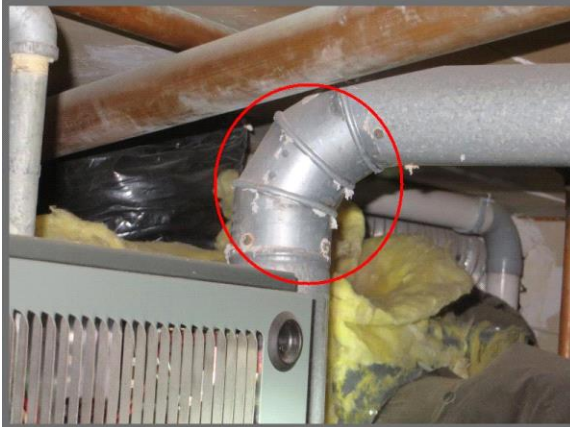
Corroded vent
